Combined Use of Physical/Morphological, Chemical, and Microbial Parameters to Assess Stream Health

Root River, Racine, WI

**2009 AWRA Annual Meeting
March 5-6, Stevens Point, WI**

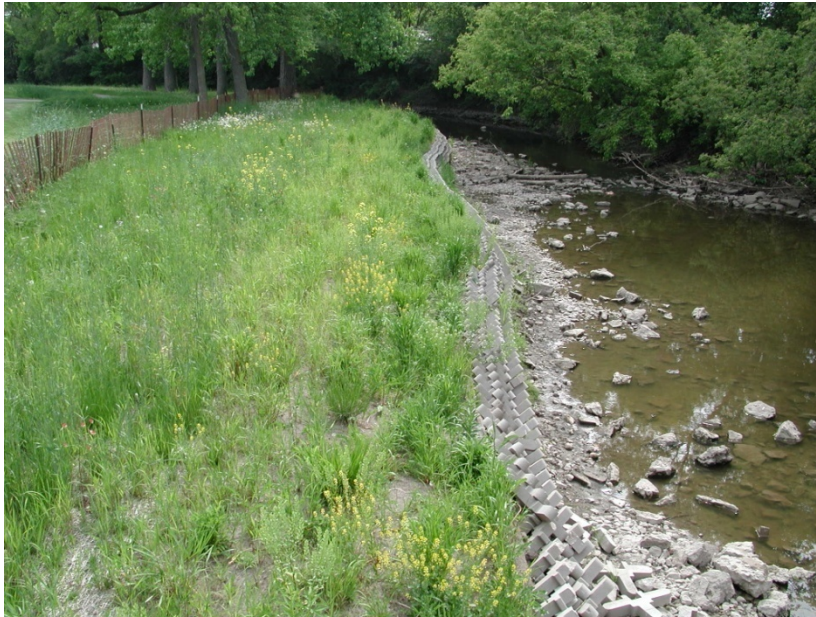
Island Park, 2005

Root River Stream Bank Stabilization Projects

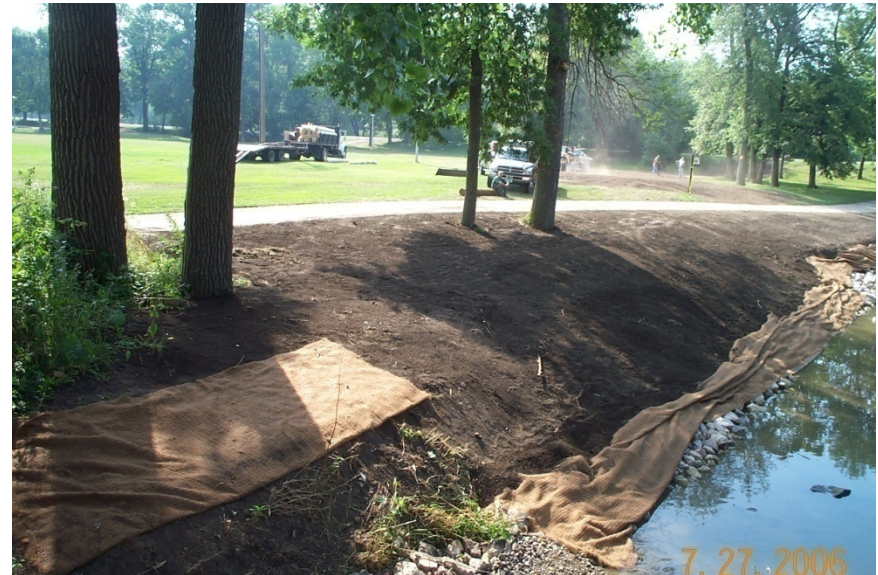
Island Park, 2006

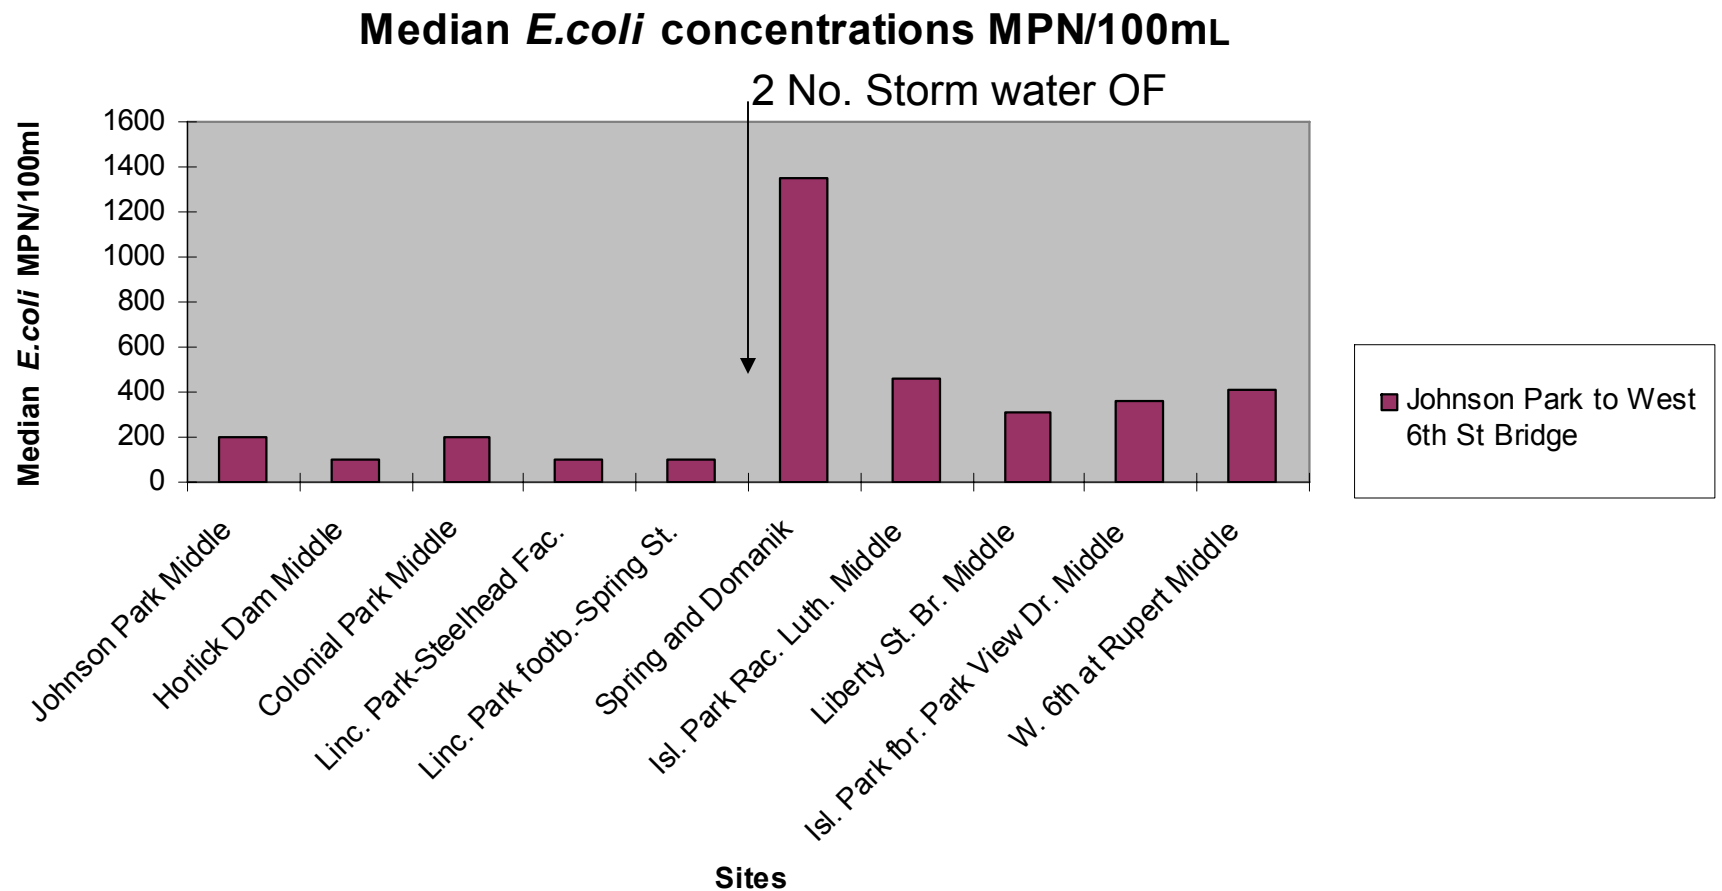
Median *E. coli* concentrations from Johnson's Park to West 6th Street

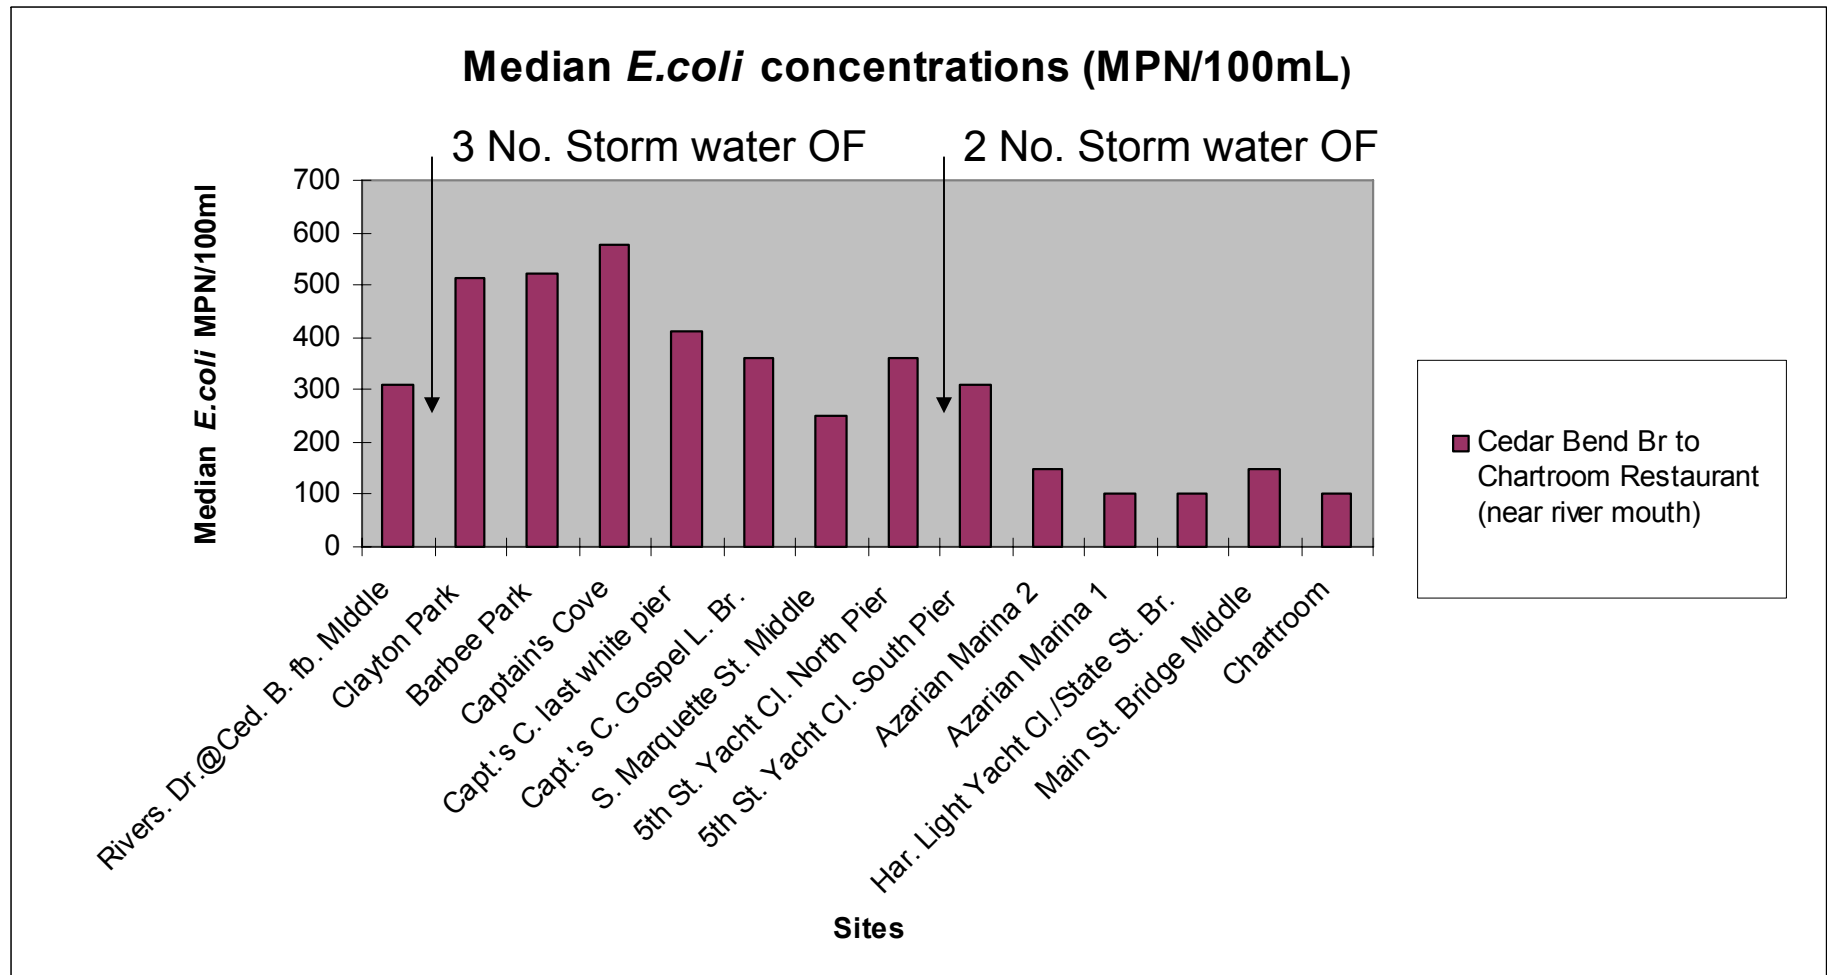
Median *E. coli* concentrations from Cedarbend Bridge to mouth of Root River

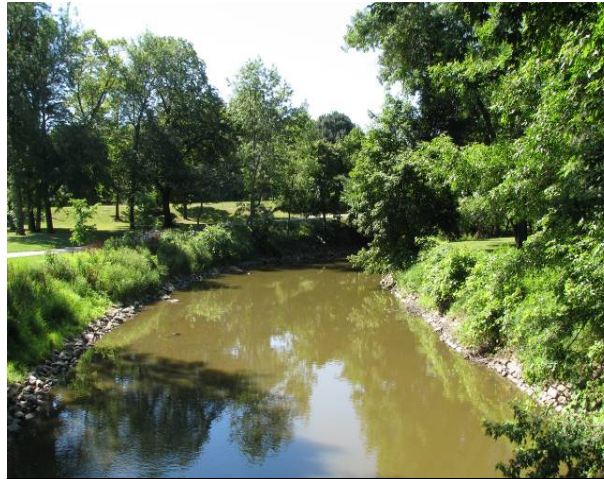
View south, downstream, from the footbridge. Both banks are in good condition.

Stream banks are in good condition with recent restoration work undertaken on the east bank adjacent to site and approximately 120m u/s (after 2005 Earth Tech stream bank assessment)

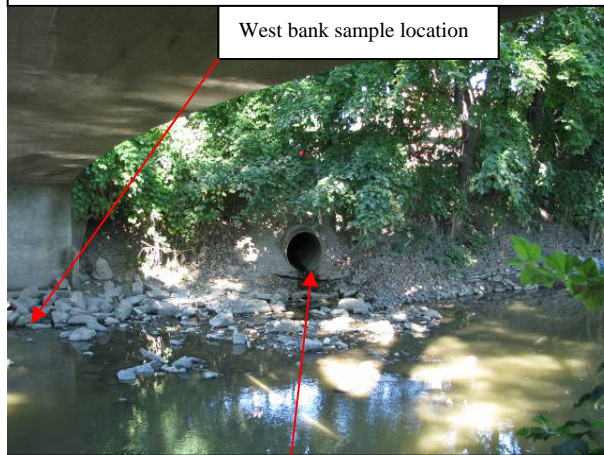
View of the outfall off Glenn Street exhibiting DWF.

Outfall (RR17) off Glenn Street adjacent to footbridge and sample locations exhibits a constant DWF.

This outfall is suspected of contributing to the high levels of *E. coli* at the sample site.

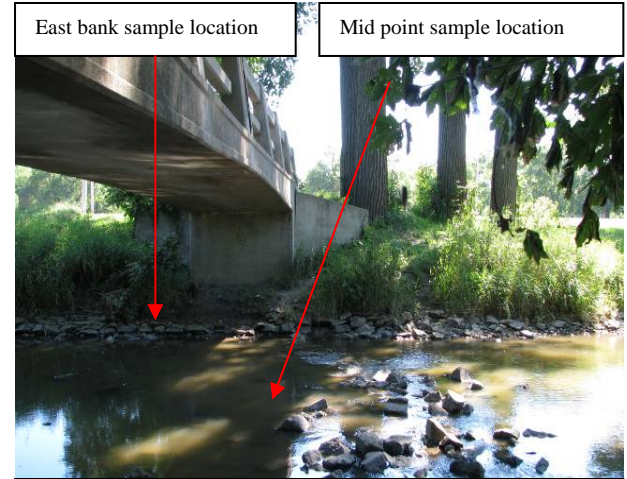
View from the west bank across to the east bank sample location.

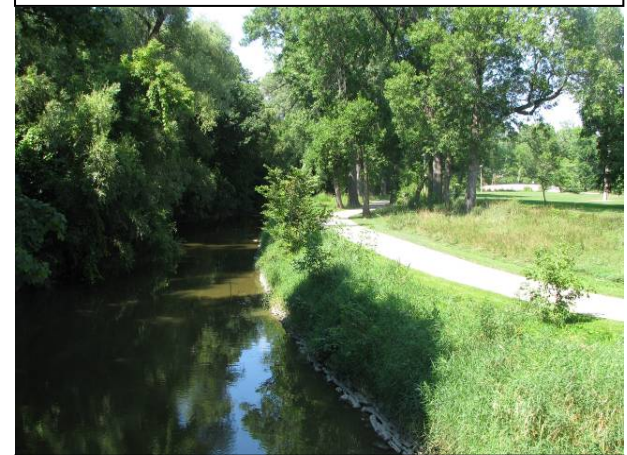
View looking north from footbridge at east bank. Conditions = high grass and little sign of erosion.

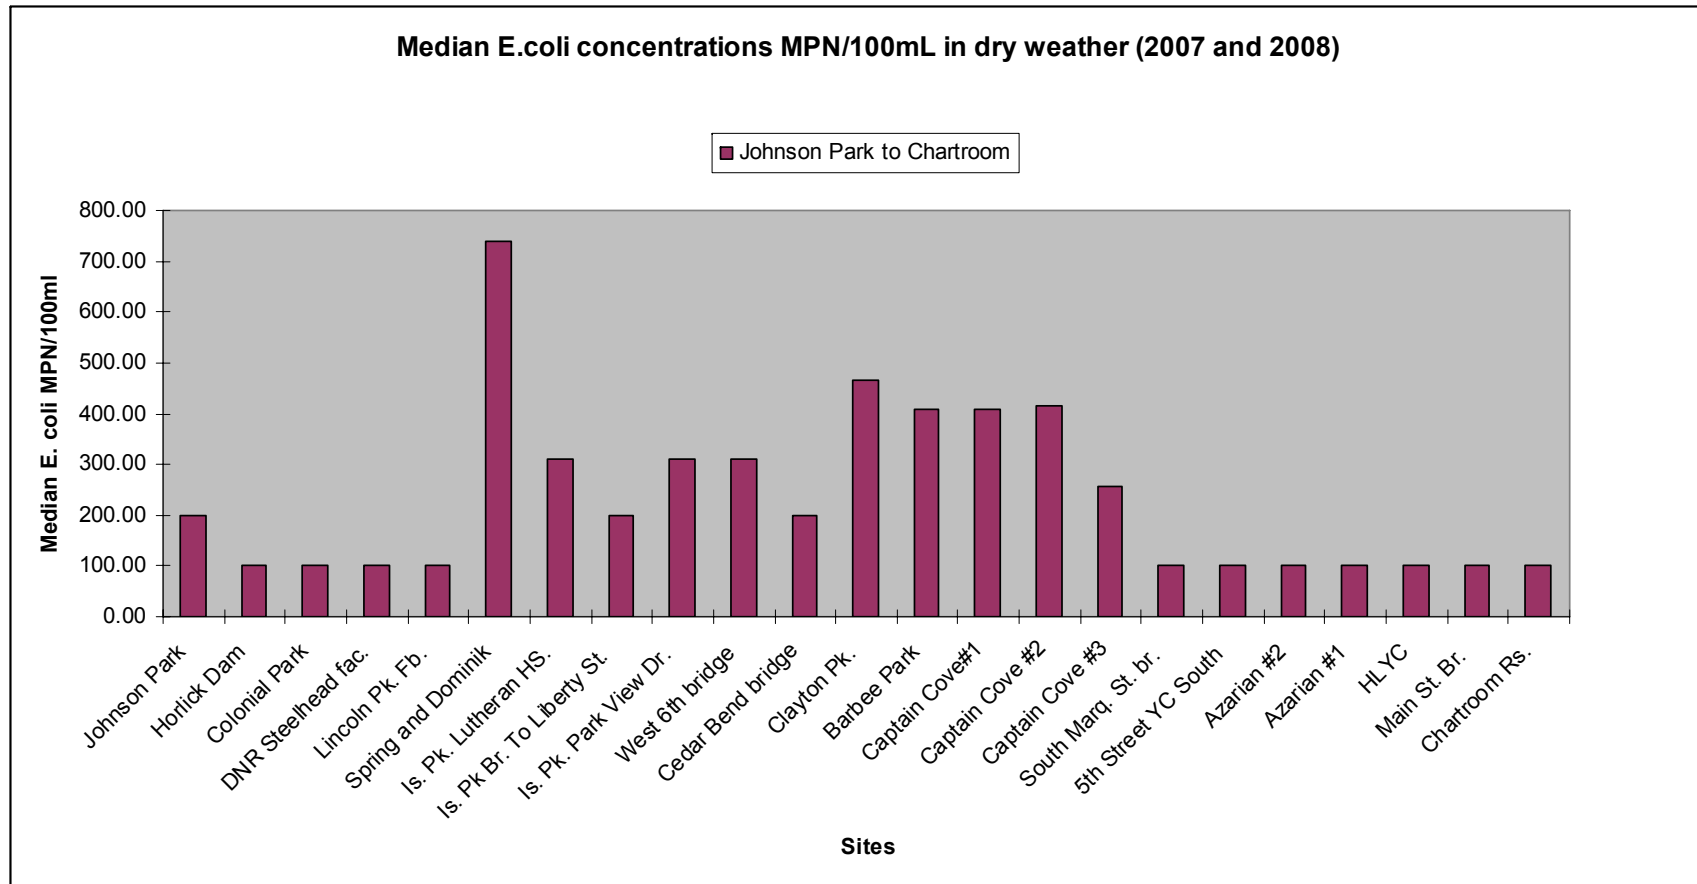
Dry Weather *E. coli*

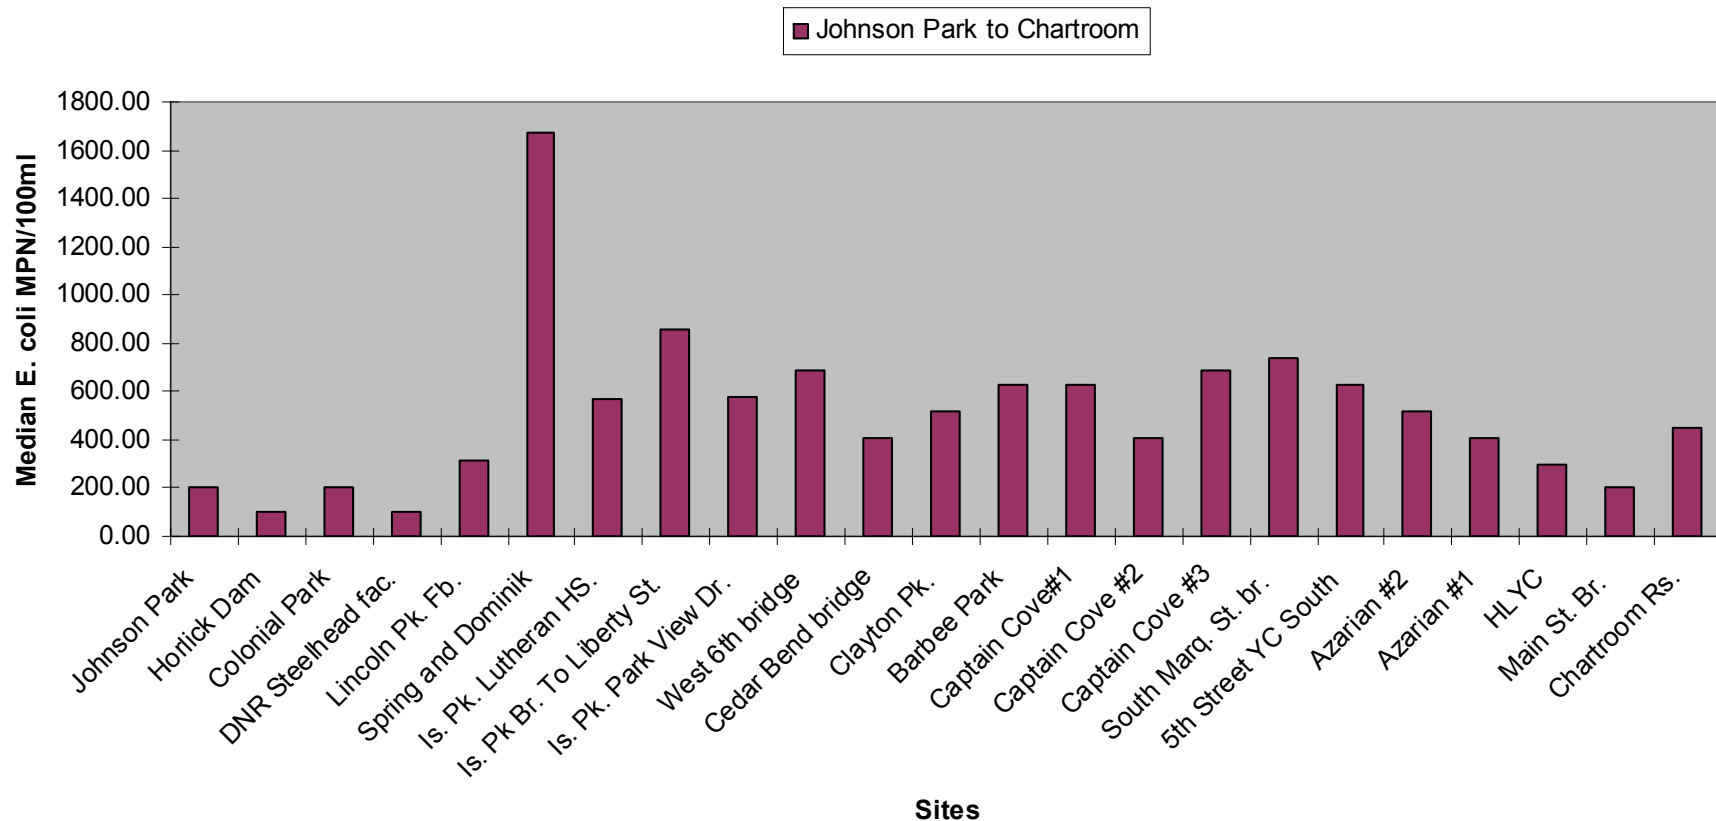
Median *E. coli* concentrations MPN/100mL in wet weather (2007 and 2008)

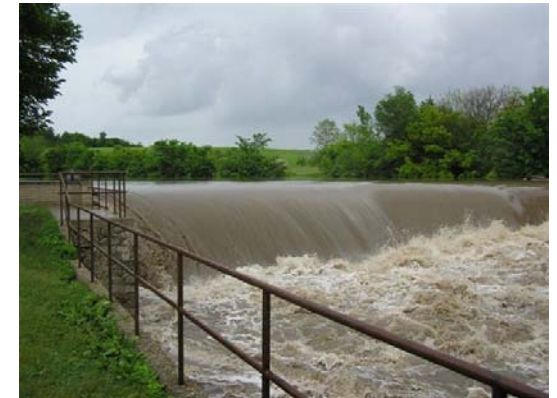
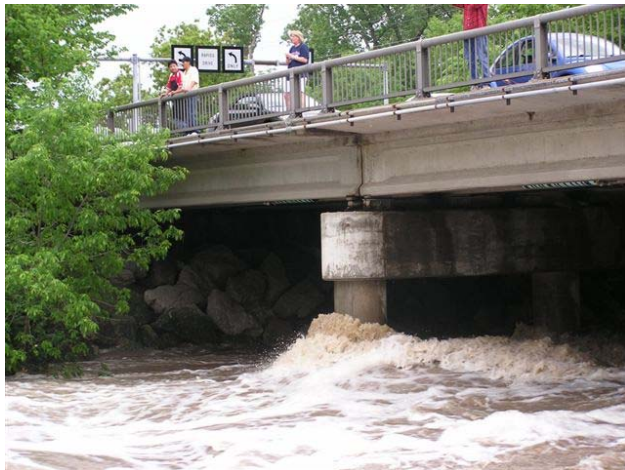
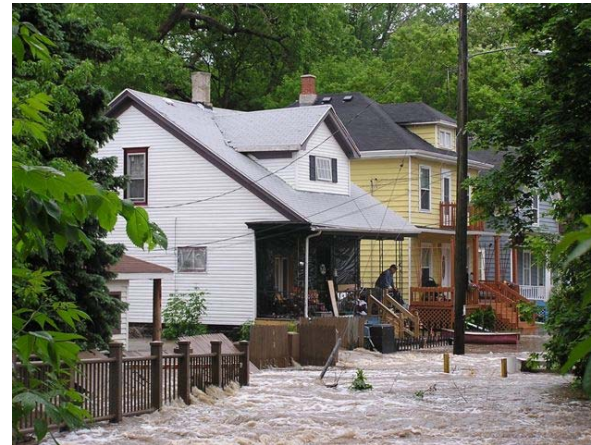
Turbidity vs. Precipitation, 2007-2008						
	Coefficient of determinations [(R ²) left column] and correlation coefficients [(r) right column] for combined and wet weather data					
PPT	Group 1 and 2		Group 3		Group 4	
24 hr	0.12	0.11	0.56	0.47	0.56	0.75
48 hr	0.28	0.53	0.60	0.44	0.61	0.78

Turbidity vs. Flow Rate, 2007-2008			
	Group 1 and 2	Group 3	Group 4
R²	0.65	0.90	0.90
r	0.81	0.95	0.95
