Guiding remediation along the Root River through the use of an integrated source tracking program

Julie Kinzelman
City of Racine, WI

7th Annual Clean Rivers, Clean Lake Conference
September 15, 2010

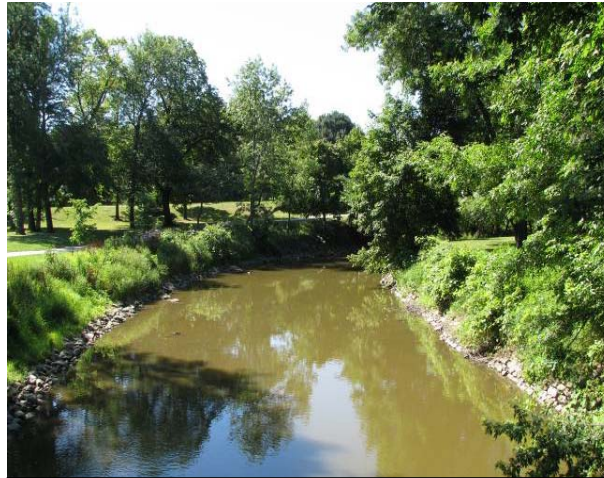
View south, downstream, from the footbridge. Both banks are in good condition.

Stream banks are in good condition with recent restoration work undertaken on the east bank adjacent to site and approximately 120m u/s (after 2005 Earth Tech stream bank assessment)

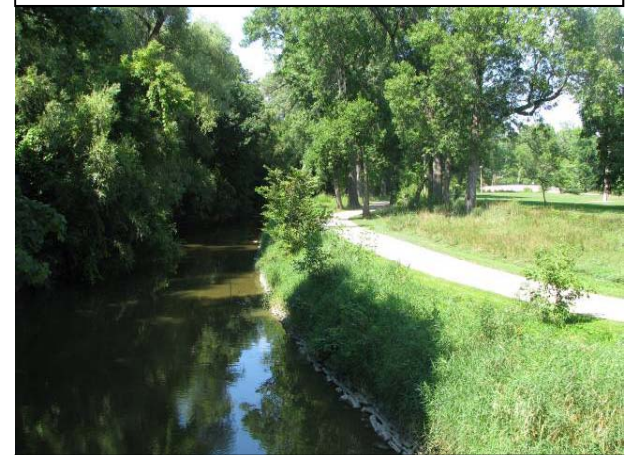
View looking north from footbridge at east bank. Conditions = high grass and little sign of erosion.

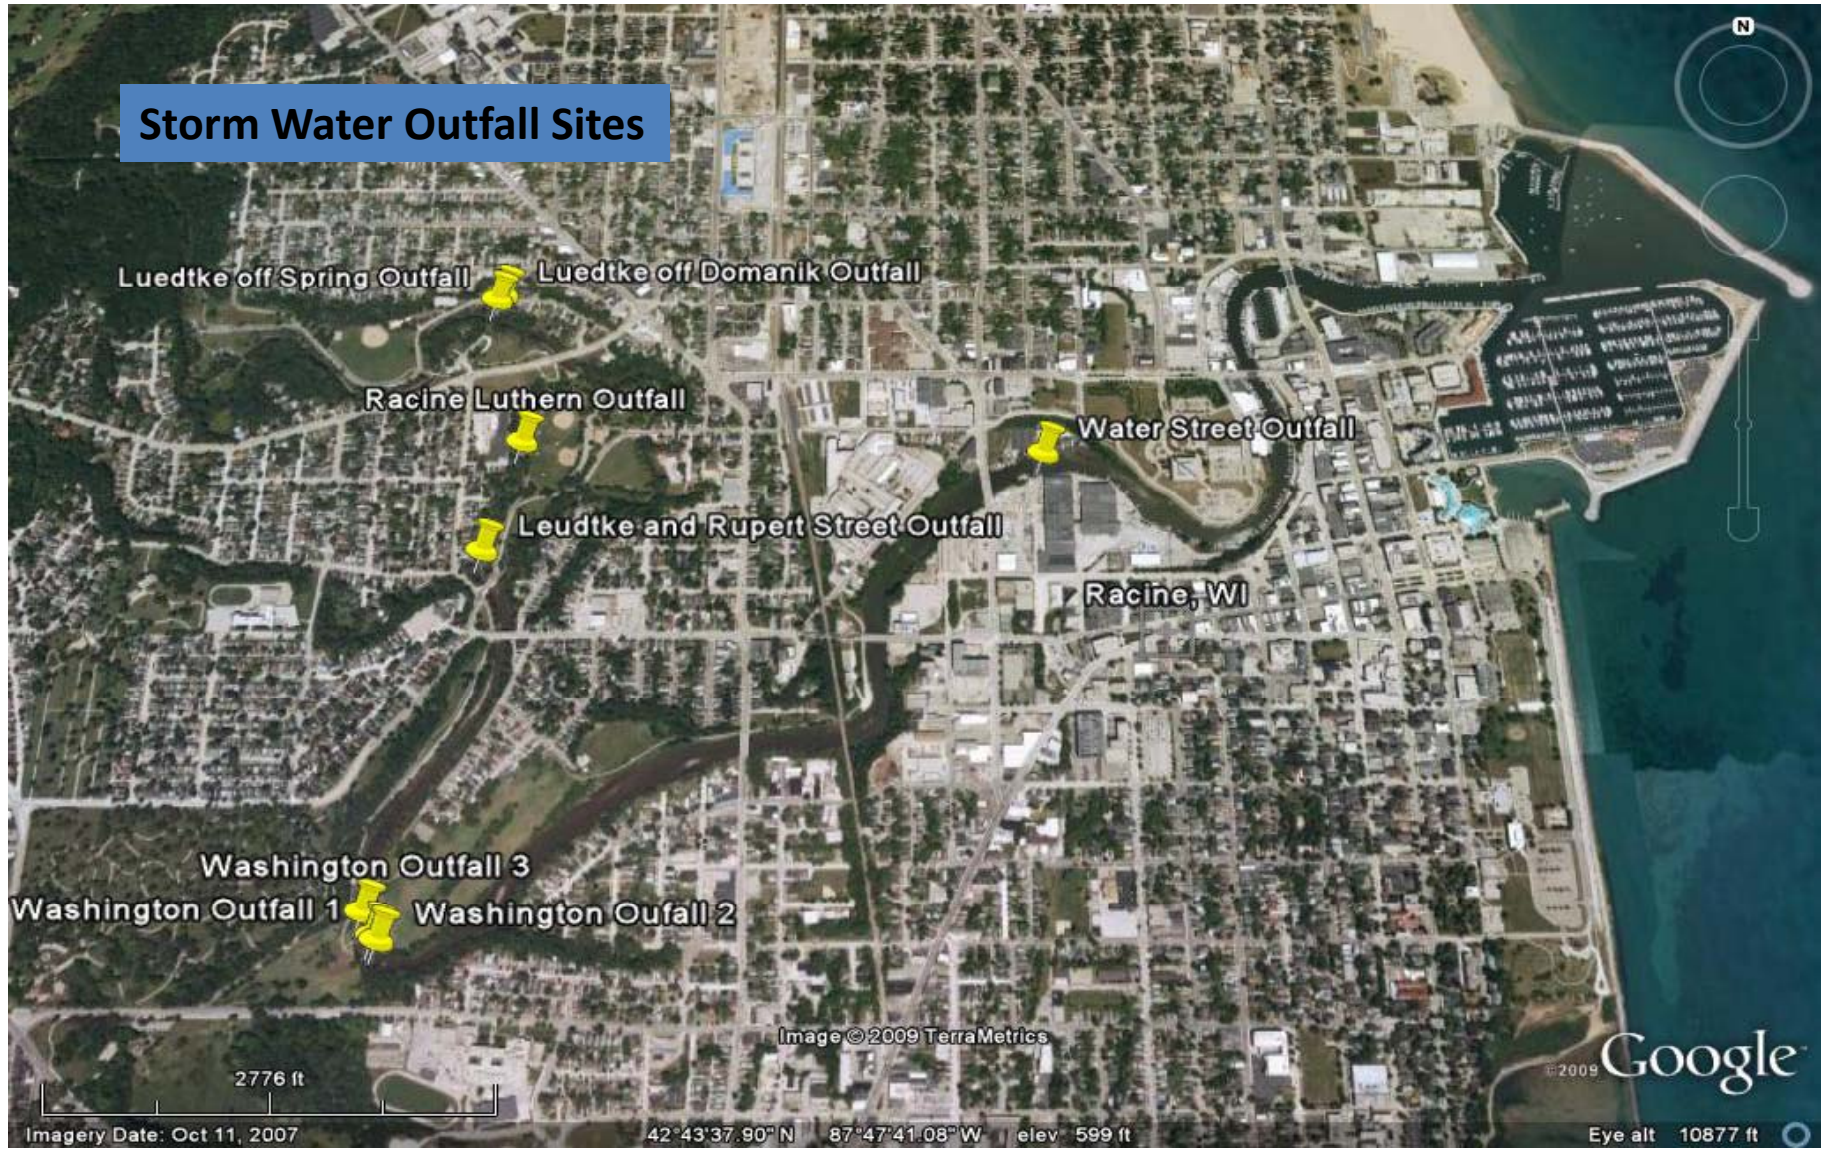
Storm Water Outfall Sites

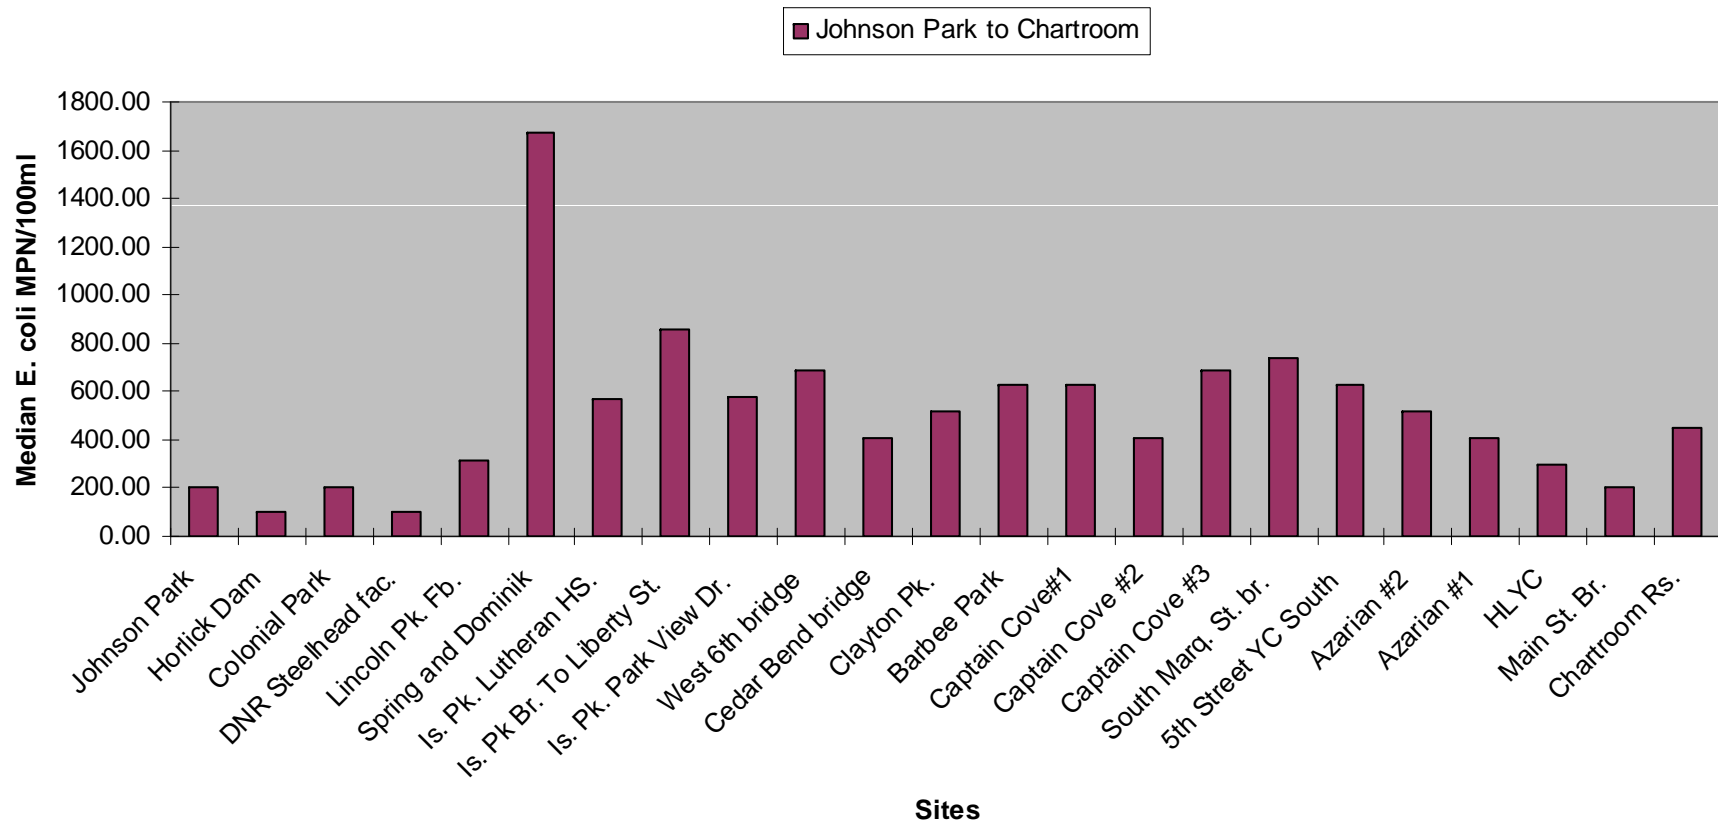
Wet weather *E. coli*

Median *E. coli* concentrations MPN/100mL in wet weather (2007 and 2008)

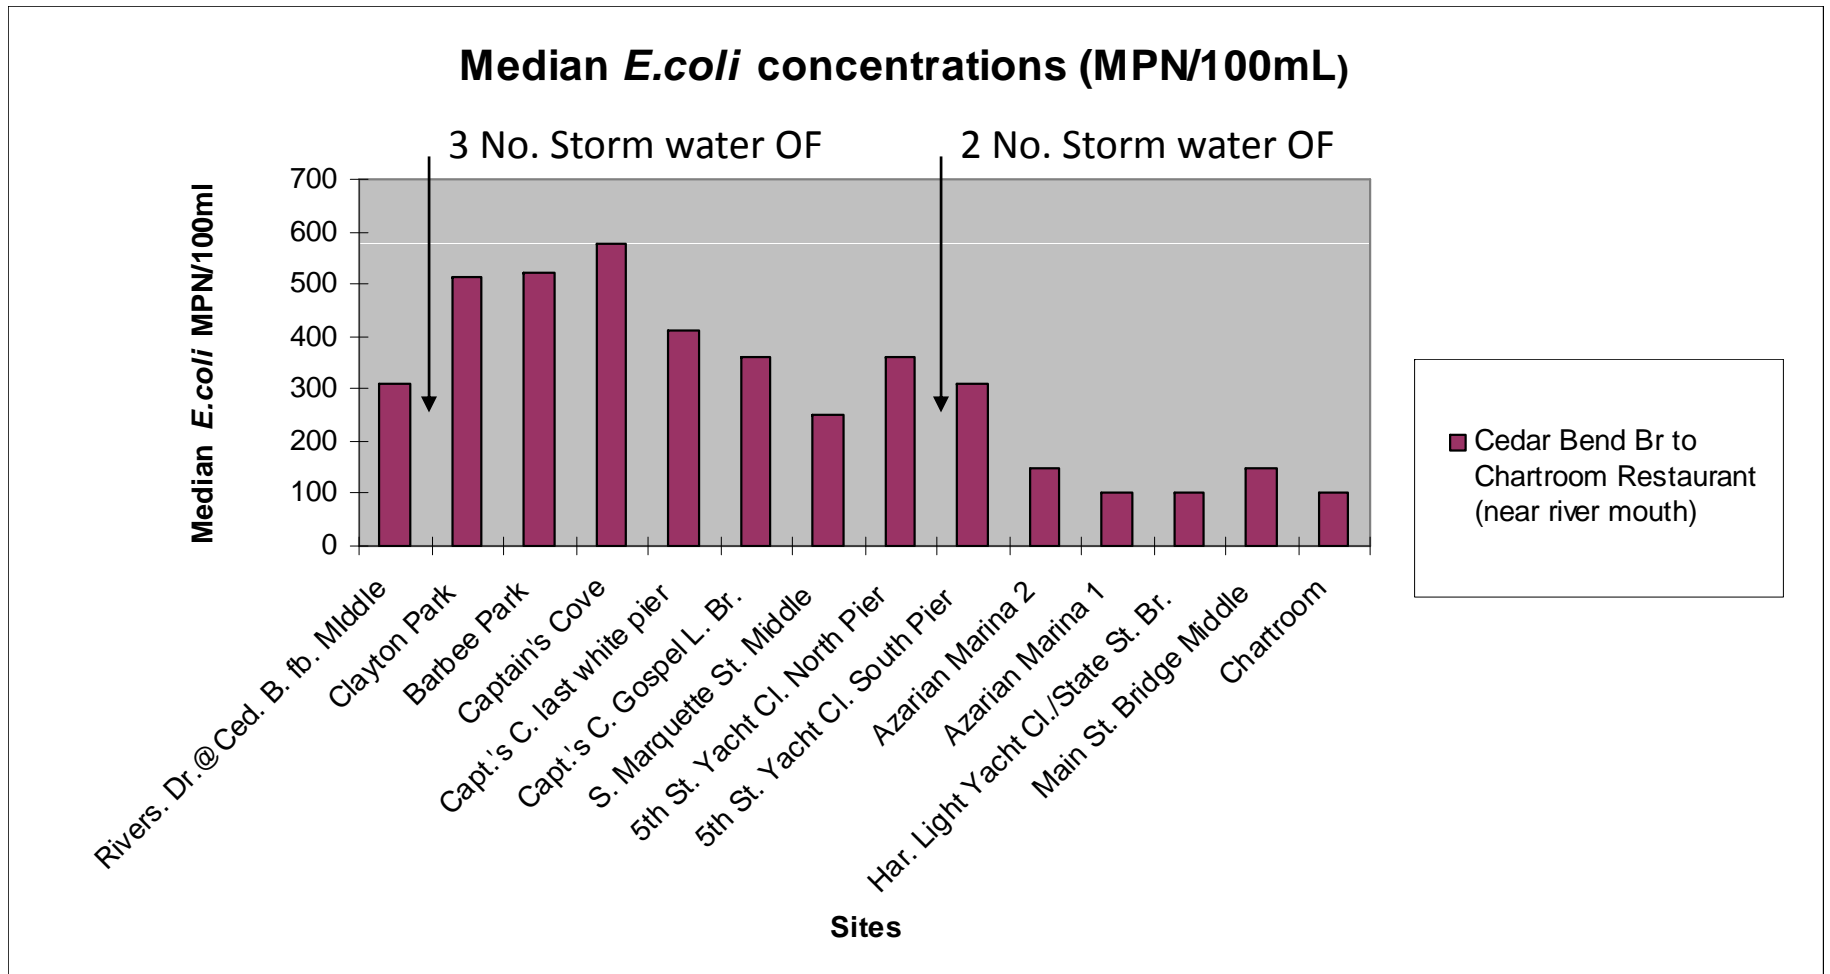
Median *E. coli* concentrations from Cedarbend Bridge to mouth of Root River

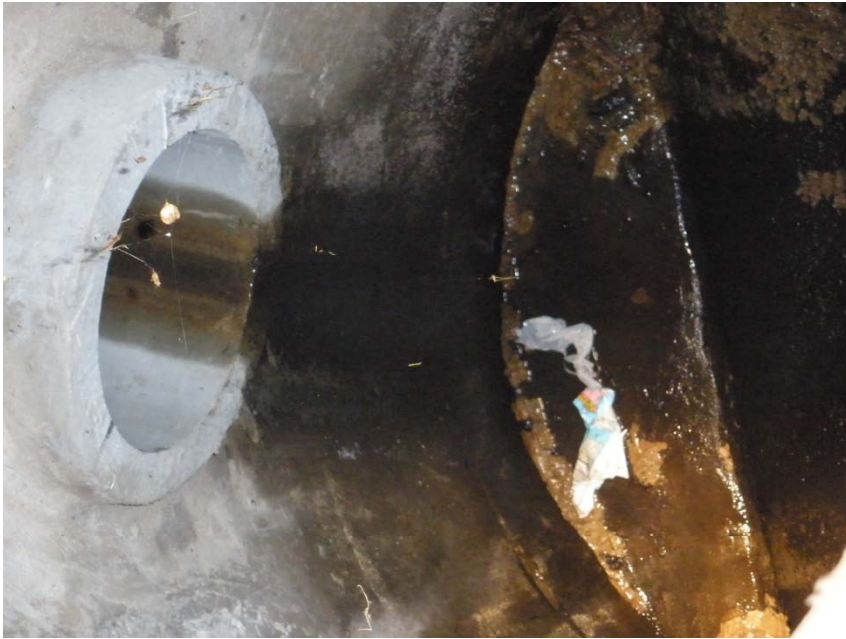
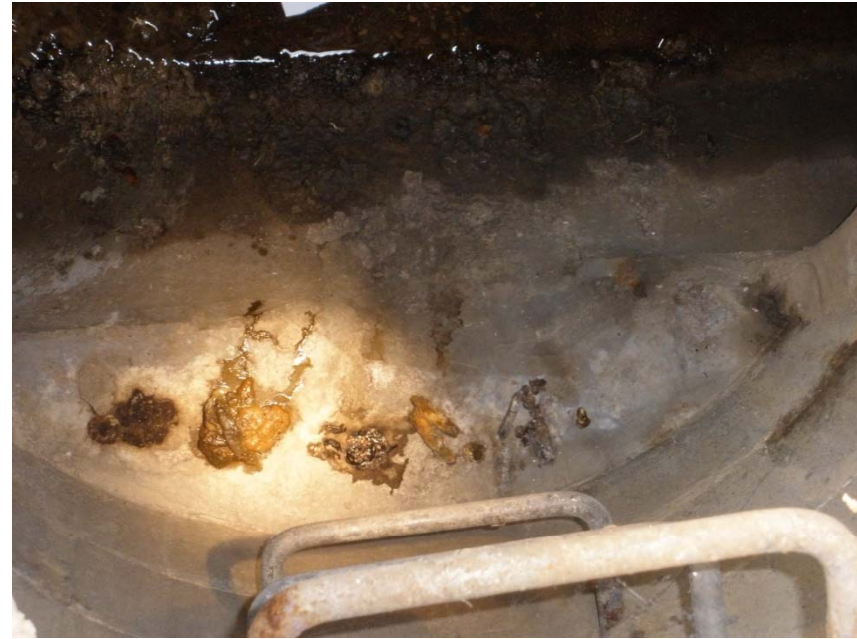
Looking for Telltale Evidence

***E. Coli* (MPN/100 ml):**

RR17003 = >241,920

RR17004 (west pipe) = 241,917

RR17002 (north pipe) = 2,780

RR17002 (west pipe) = 30,760

RR17005 = 30,760

Racine Lutheran Outfall = 77,010

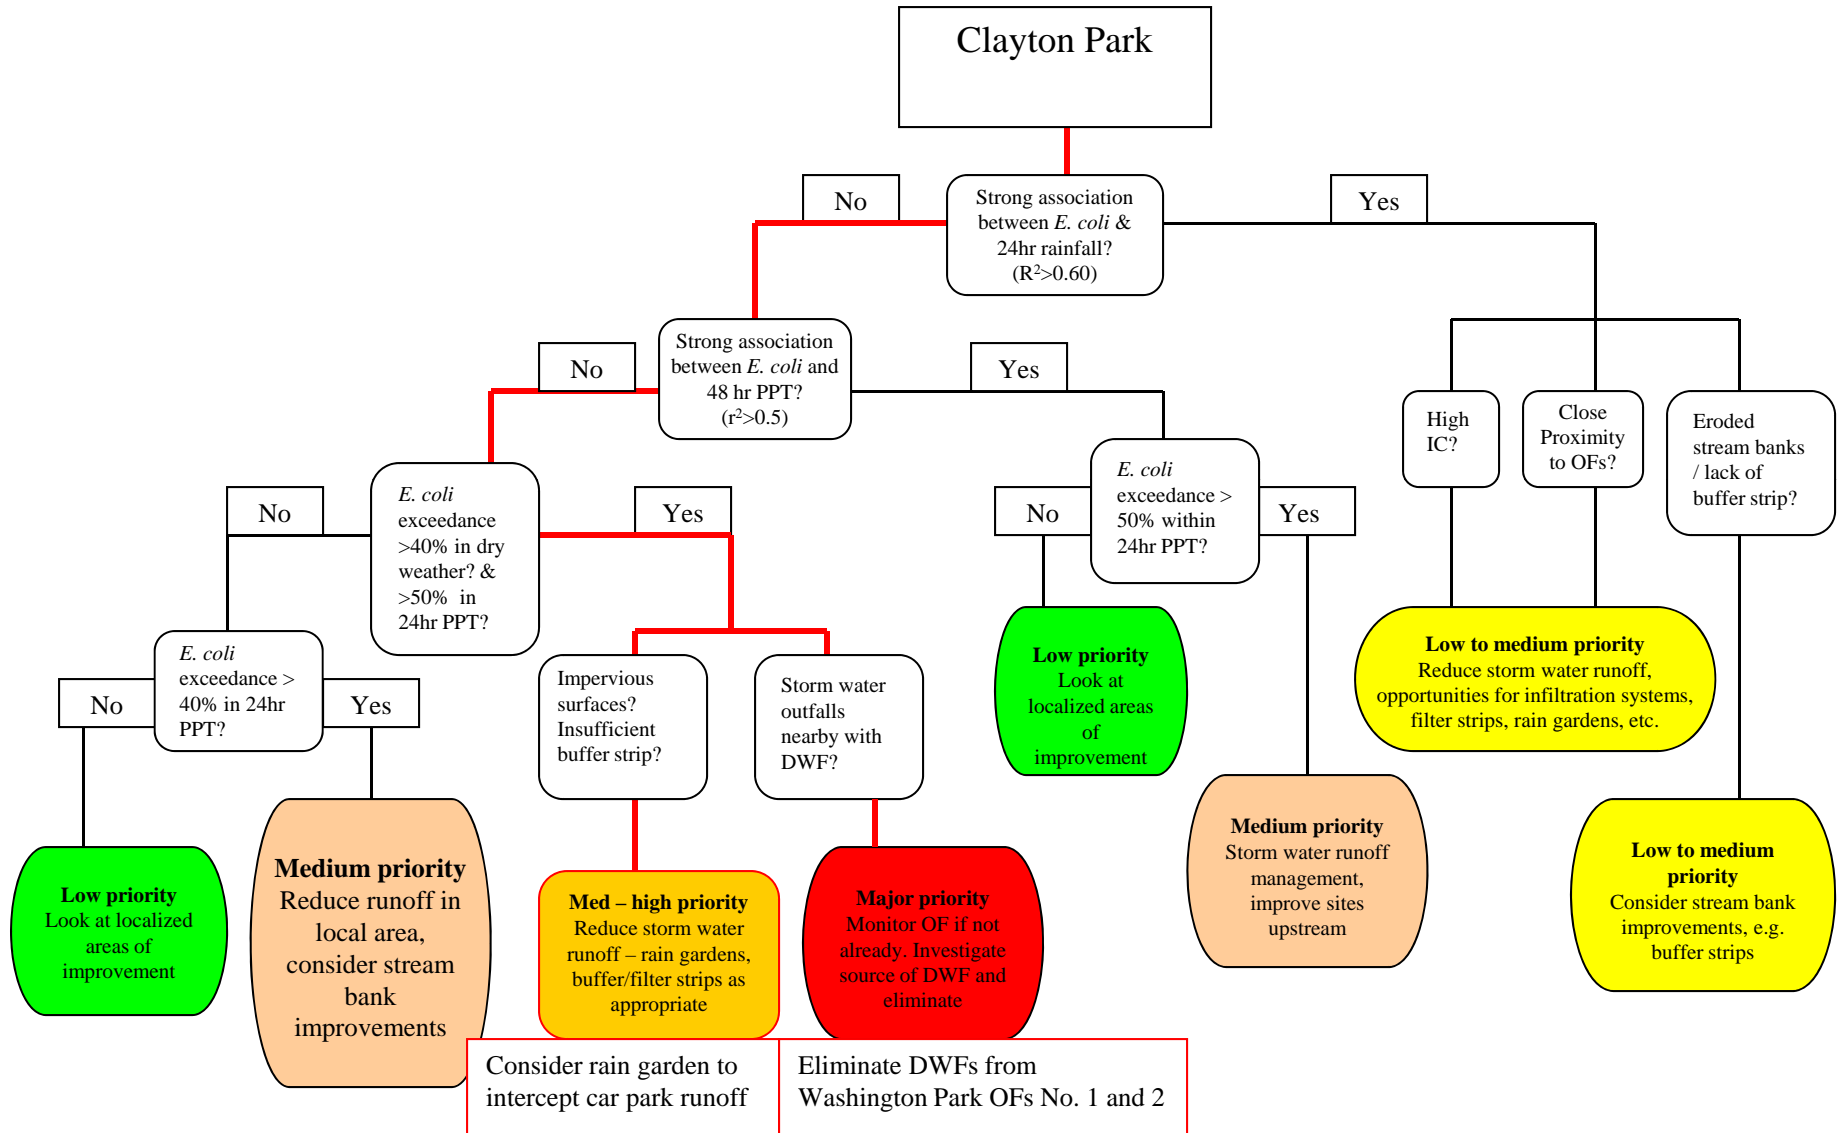
Clayton Park

Azarian Marina -
Sampling Point #2,
upstream

No Strong association
between *E. coli* &
24hr rainfall?
($R^2 > 0.60$) Yes

No Strong association
between *E. coli* and
48 hr PPT?
($r^2 > 0.5$) Yes

No *E. coli*
exceedance
>40% in dry
weather? &
>50% in
24hr PPT? Yes

No *E. coli*
exceedance >
40% in 24hr
PPT? Yes

Low priority
Look at localized
areas of
improvement

Medium priority
Reduce runoff in
local area,
consider stream
bank
improvements

Impervious
surfaces?
Insufficient
buffer strip?

Med – high priority
Reduce storm water
runoff – rain gardens,
buffer/filter strips as
appropriate

Storm water
outfalls
nearby with
DWF?

Major priority
Monitor OF if not
already. Investigate
source of DWF and
eliminate

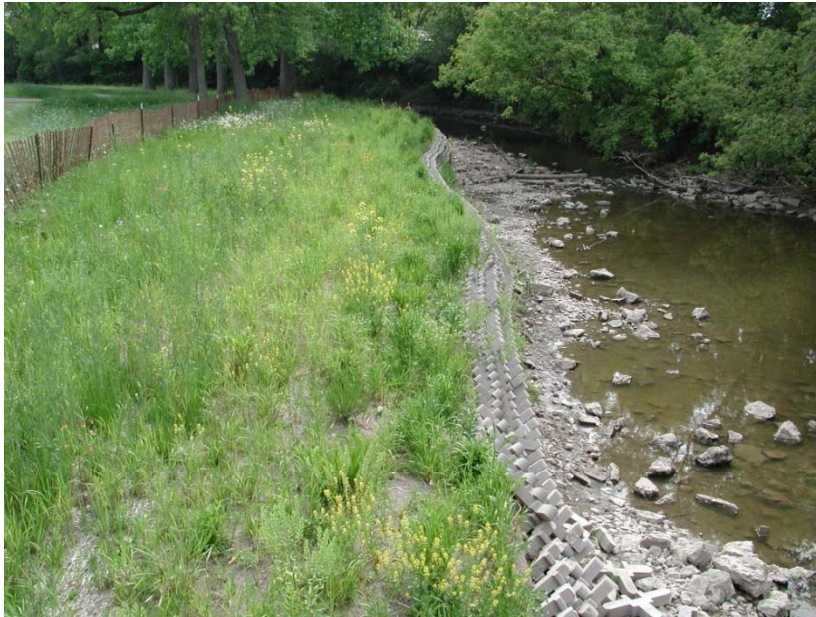
Root River Stream Bank Stabilization Projects

Island Park, 2005

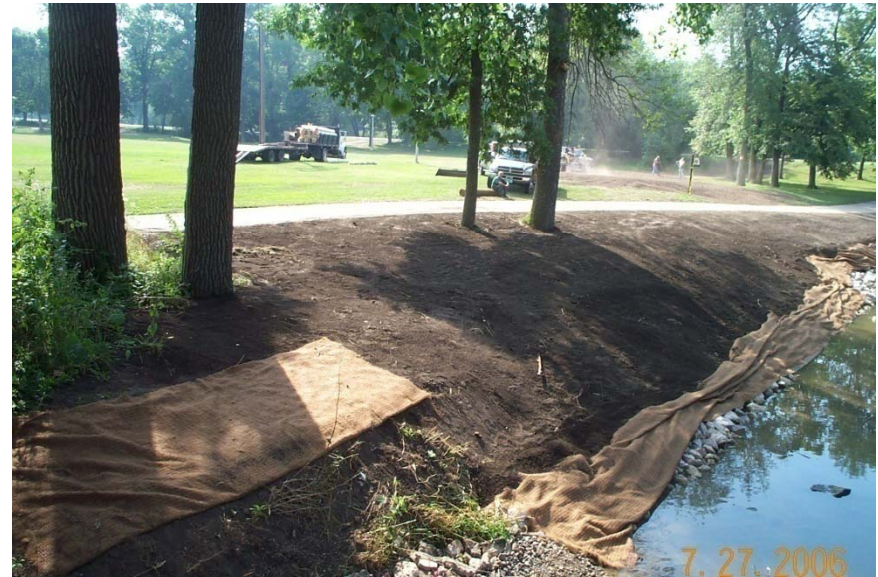
Island Park, 2006

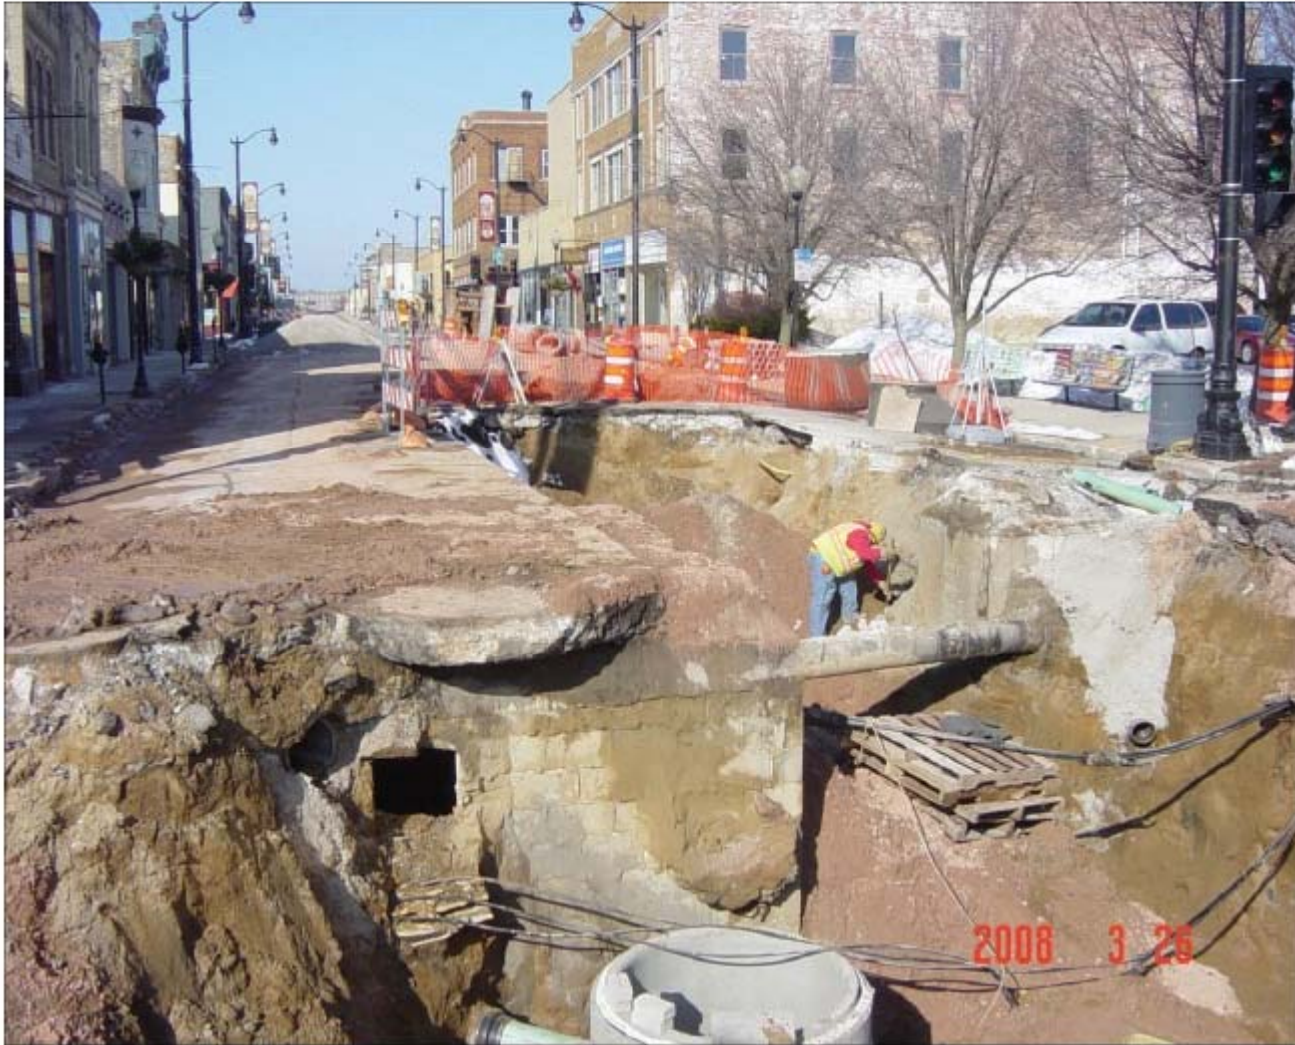
Sewer work in the 400 Block of Sixth Street
